FINAL REPORT ON

ENGINEERING TEST

RECOVERY VEHICLE, FULL-TRACKED,

XM806E1

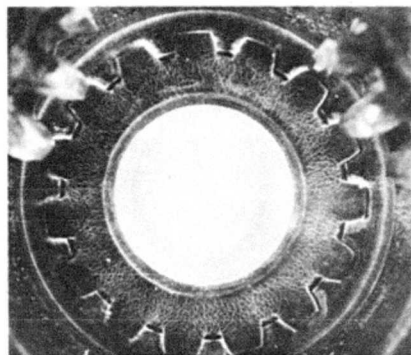
Figure II-26: New Second Stage Sun Gear As Received from the Manufacturer. The Assembly Was Intended for Use As A Replacement Component. Surface Cracks Probably Resulted from Heat Checking during Grinding Operations.

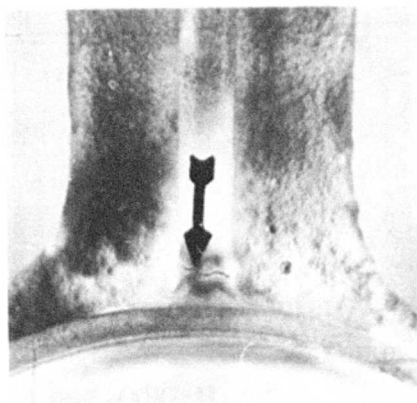
Figures II-27(a) and II-27(b): Arrows Point to Typical Cracks Found in Level Wind Floating Pulley Spoke Support Ribs. Figure II-27(a) Shows Pulley for the XM806E1 Vehicles and Figure II-27(b) Shows the Pulley for the M113 Recovery Vehicle.

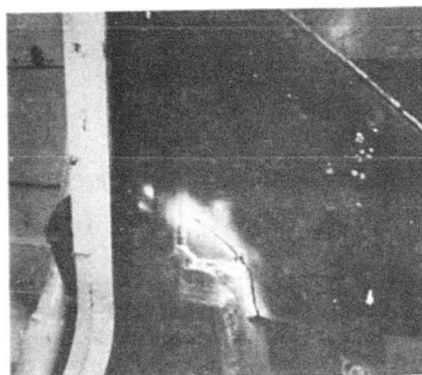
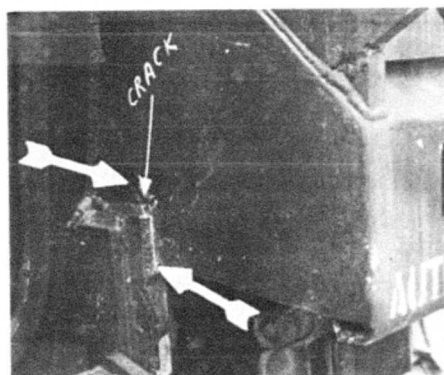
Figures II-28(a) and II-28(b): Figure II-28(a) Shows Crack Found in Right Fender of the XM806E1 during Final Inspection. The Crack Has Been Accented with Dye. Figure II-28(b) Shows Right Fender After the Final Inspection of M113 Recovery Vehicle.
